Manhole Inspection Summary

Manhole # S31WW_008MH

Location Address: **3122 REMINGTON AVE**

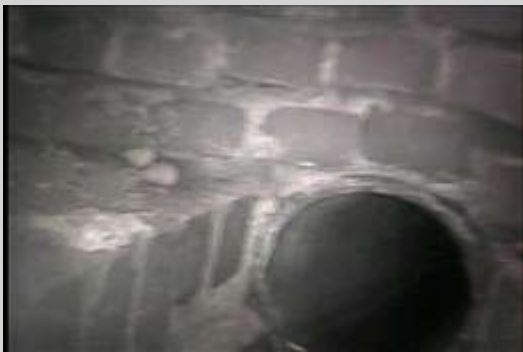
Pipe Out @ 12 O'Clock

8 in. Circular Gravity Sewer

Pipe Material: **Clay** ☐ Pipe Lined

Invert Depth: **7.80** (ft.) Flow Characteristics: **Slow**

Deposits: ☒ None ☐ Mud ☐ Sludge ☐ Debris ☐ Grease

Infiltration: **None** Pipe Seal Cond: **Unknown**

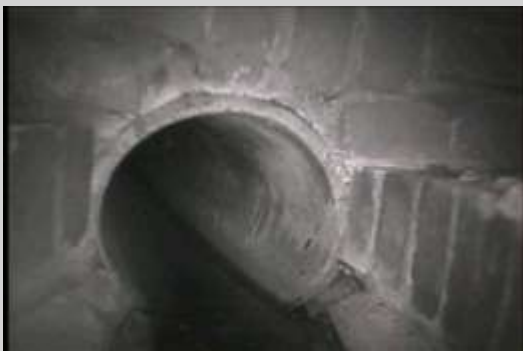
Pipe In @ 3 O'Clock

8 in. Circular Gravity Sewer

Pipe Material: **Clay** ☐ Pipe Lined

Infiltration: **None** Pipe Seal Cond: **Unknown**
